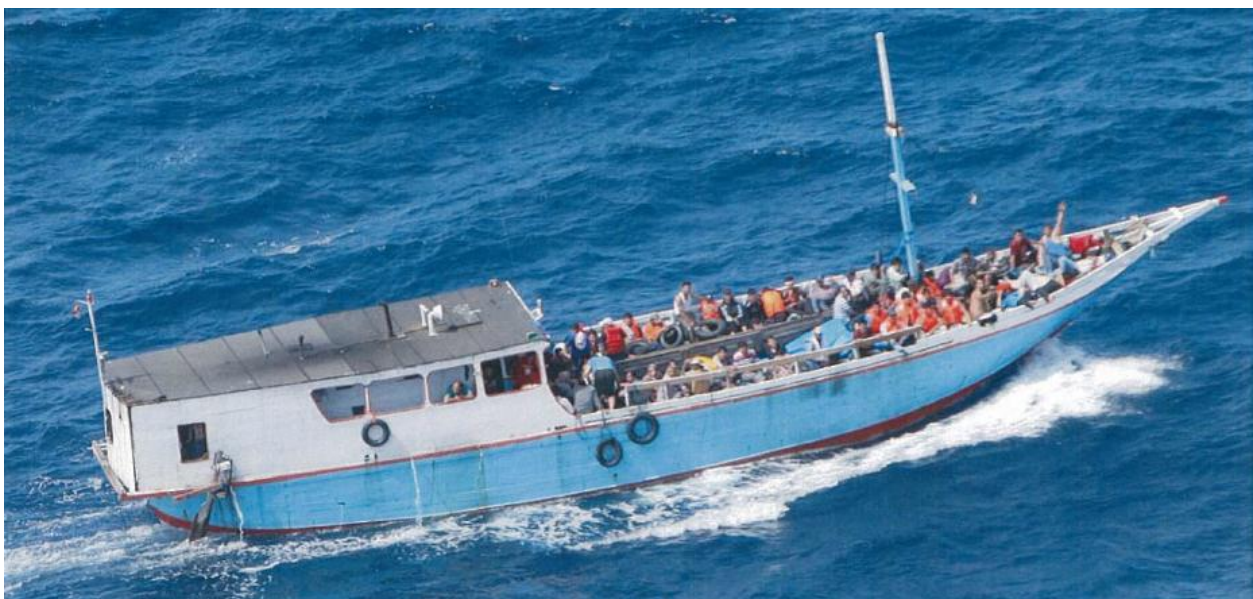
120. At the initial sighting of COI 1512 at 15:21 on 15 July, she was observed by the RAAF MPA as being 136 nm north north east of Christmas Island, underway and tracking 182° at 3 knots.

Figure 6. Initial sighting of COI 1512 at 15:21 on 15 July

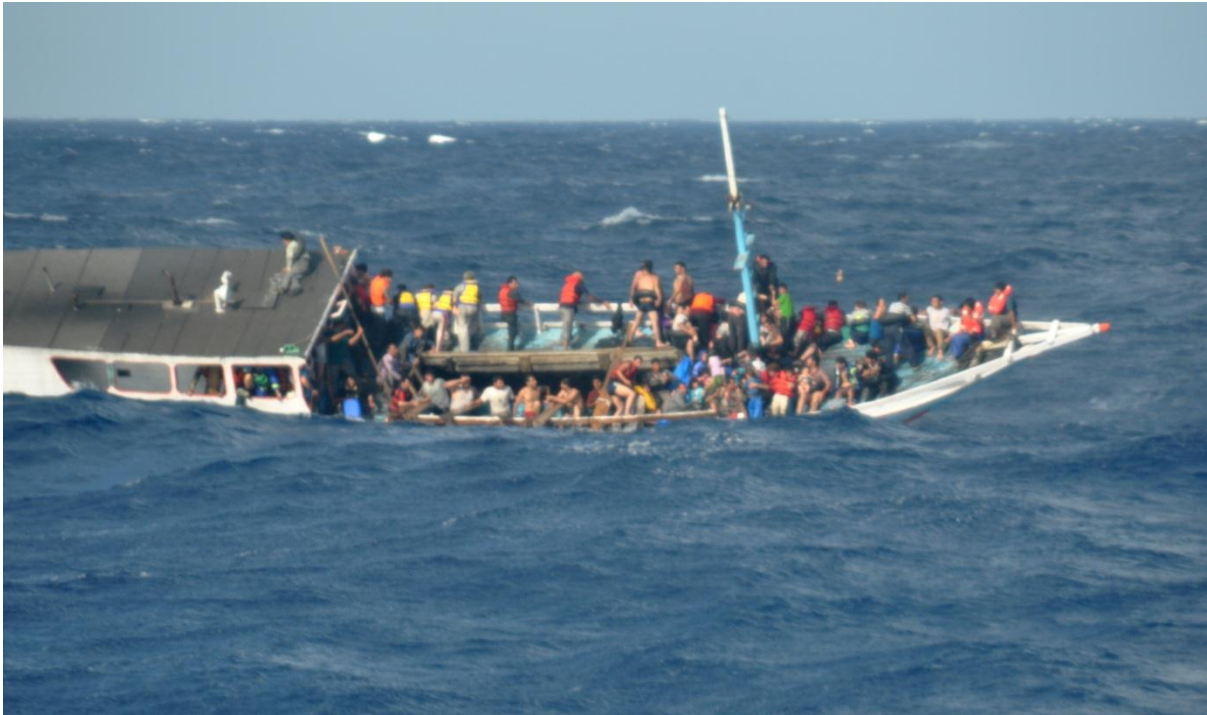
148. The Review found that as a result of no longer being able to make way and the continued ingress of water, the stability of COI 1512 was compromised, and she became vulnerable to swamping. This was exacerbated by the prevailing sea state and the fact that she was overloaded.

149. The photograph in Figure 7 taken at approximately 18:15, shows the vessel subject of SAR 2013/4816 becoming beam on to the sea, and listing heavily to starboard as a result of seawater ingress, which ultimately led to the capsizing of the vessel.

150. The Review found that the poor condition of the vessel, its overloaded nature and ingress of water resulted in the capsizing of COI 1512.

Figure 7. COI 1512 listing heavily to starboard

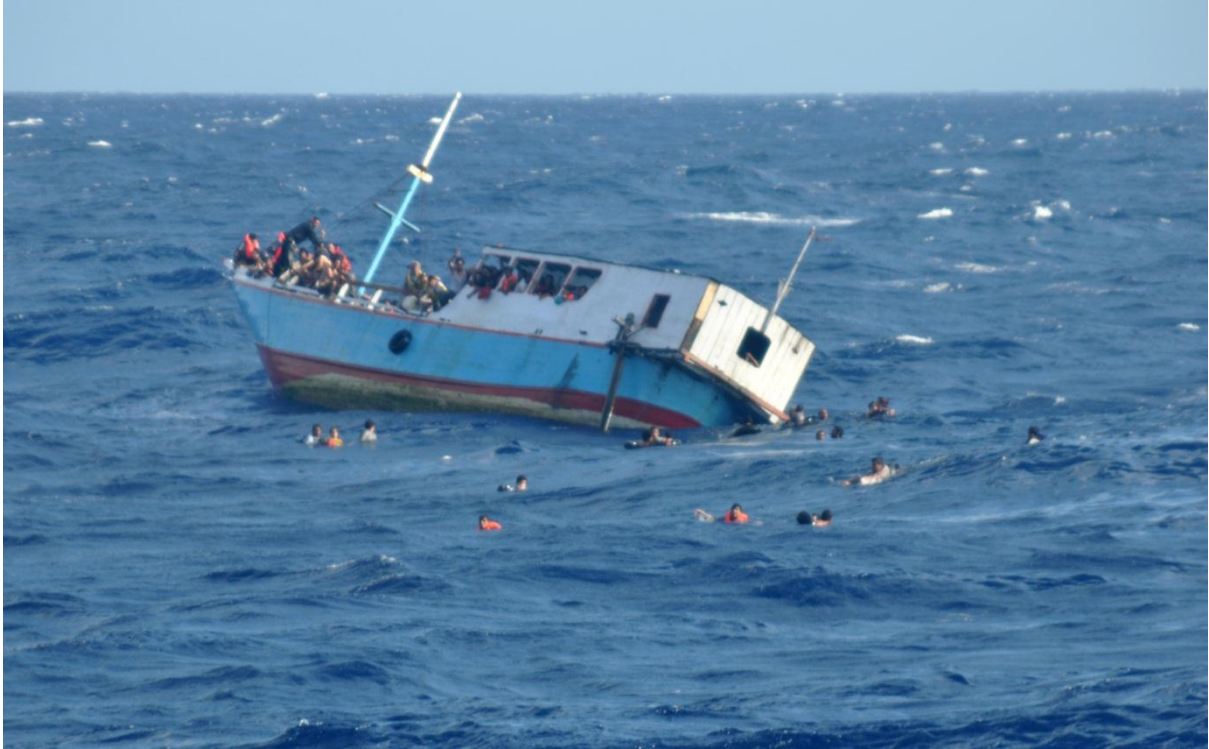
Figure 8. People from COI 1512 in the water prior to capsize at 18:41 on 16 July
