Australian Government
Australian Customs and
Border Protection Service

SAR 2013/4724

Internal Report

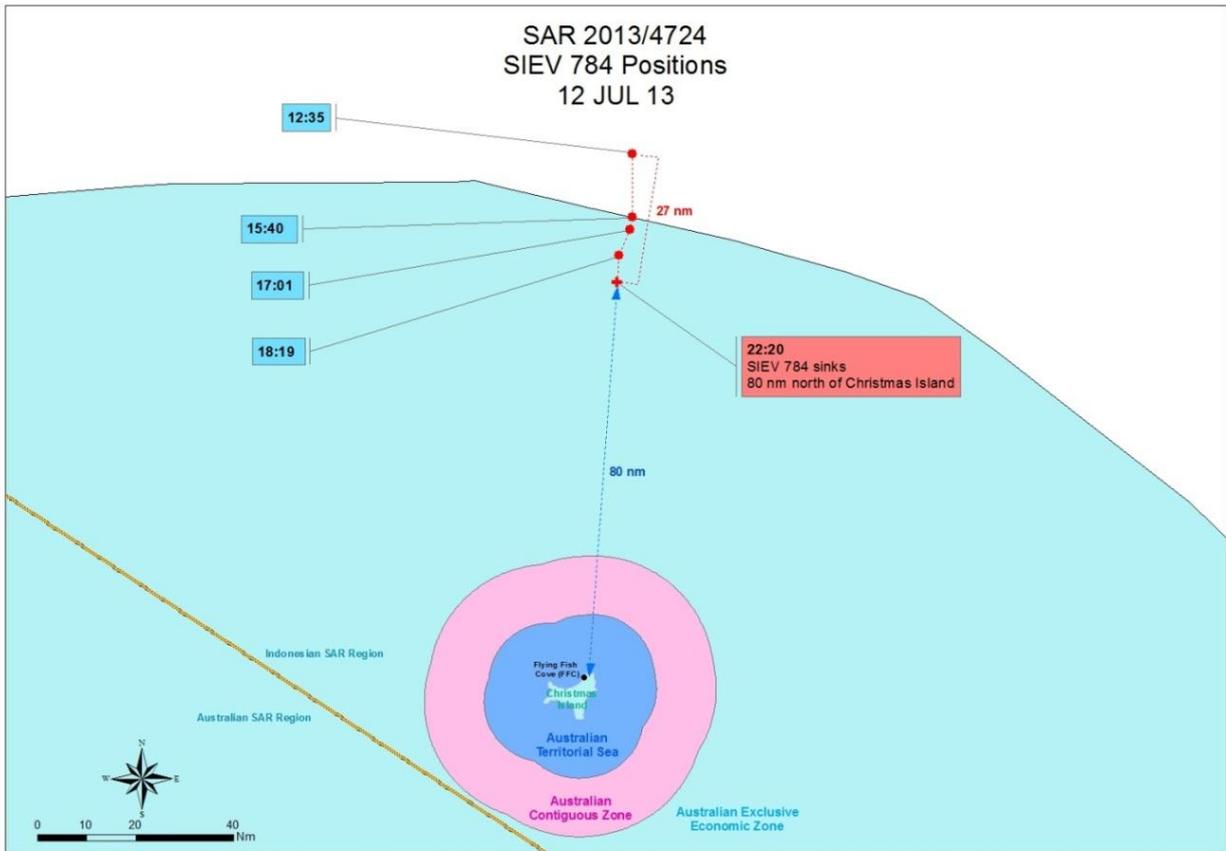
Figure 3: SIEV 784's positions

78. At 19:00 RCC advised AMSOC that it had been in further contact with SIEV 784 and was able to provide an updated position (as of 18:19) of approximately 87 nm north of Christmas Island. Based upon this, AMSOC advised that *Triton*’s new ETA would be 22:00.

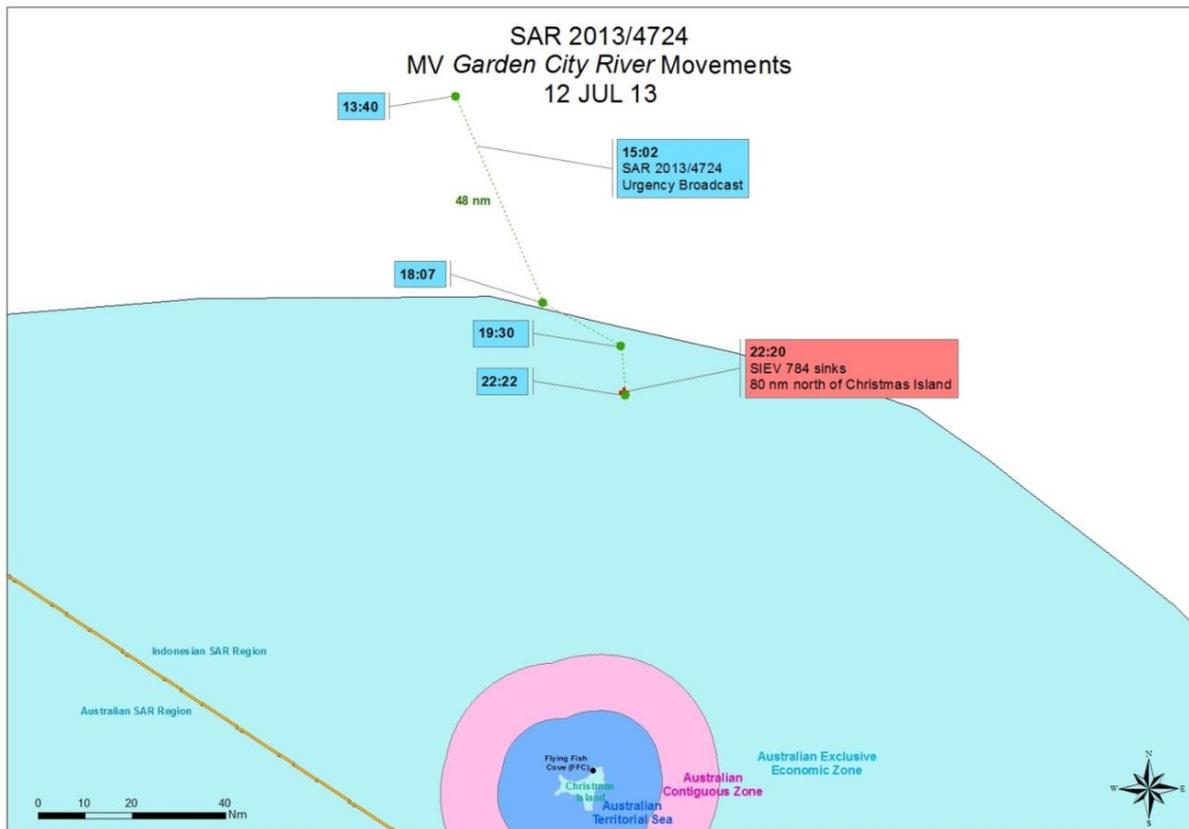
Figure 4: Garden City River's Movements

79. *Garden City River* advised *Triton* at 20:33 that she had SIEV 784 on radar at a range of five nm. Two minutes later, at 20:35 RCC advised AMSOC that they had just spoken to the vessel. SIEV 784 told RCC that they could see a large ship and that they were taking onboard water. RCC advised SIEV 784 to not shut off their engine and to keep making way.
80. *Garden City River* updated *Triton* at 20:44 to advise they were one mile from SIEV 784 who was flashing lights in their direction (Figure 4). They reported that SIEV 784 was now on a north easterly heading and making very slow headway, they also described that there were 10 people visible on deck, some of them wearing lifejackets.

81. At 21:01 *Garden City River* advised *Triton* that they were six cables (1200 yards) from SIEV 784 and it was no longer making way. After learning that SIEV 784 was not making way, *Triton* requests that *Garden City River* alter course to the south to close *Triton* in order to entice SIEV 784 to resume making way and follow her.
82. At 21:41 *Triton* briefed AMSOC that the weather conditions were outside the parameters for what is considered safe for normal operations and obtained approval to launch her tenders.

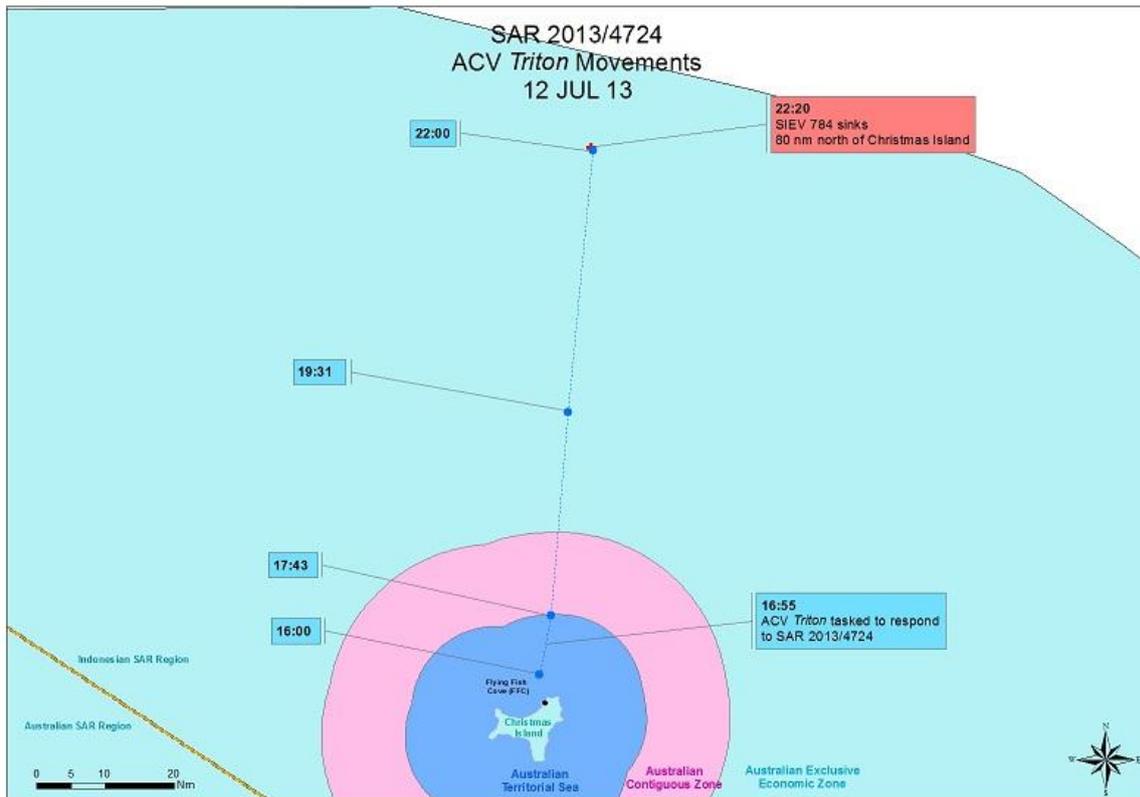
Figure 5: ACV Triton's Movements

83. Sunset on 12 July occurred at 20:51 and by the time *Triton* arrived at SIEV 784's location total darkness had set in. At 22:03 *Triton* arrived at the position of SIEV 784 and commenced launching her tenders. In addition to a boat's crew of a Coxswain and a Bowman, Fender 2³ carried a Boarding Party (BP) consisting of eight personnel and was the lead boat for the boarding operation. Fender 1 was the tender working in support of the BP and carried a boat's crew of two personnel and was loaded with SOLAS lifejackets should they be required by the PIIs.

84. At 22:12 three members of the BP boarded SIEV 784 and immediately conducted an initial safety inspection. The Boarding Commander (BC) assessed the vessels condition noting approximately 20 centimetres of water in the engine bay bilge below the engine block. The engine was dead and the bilge pump was being manually operated. At the time of boarding, SIEV 784 was stopped in the water on a westerly heading with the weather on her port side. The BC observed seeing people under the foredeck and instructed them to come out onto the deck. Very few of the PIIs on board were wearing lifejackets and the BC called for **Tender 1** to pass the SOLAS lifejackets to the BP onboard SIEV 784. Once this was done, the BP commenced distributing these and assisted the PIIs to put them on.

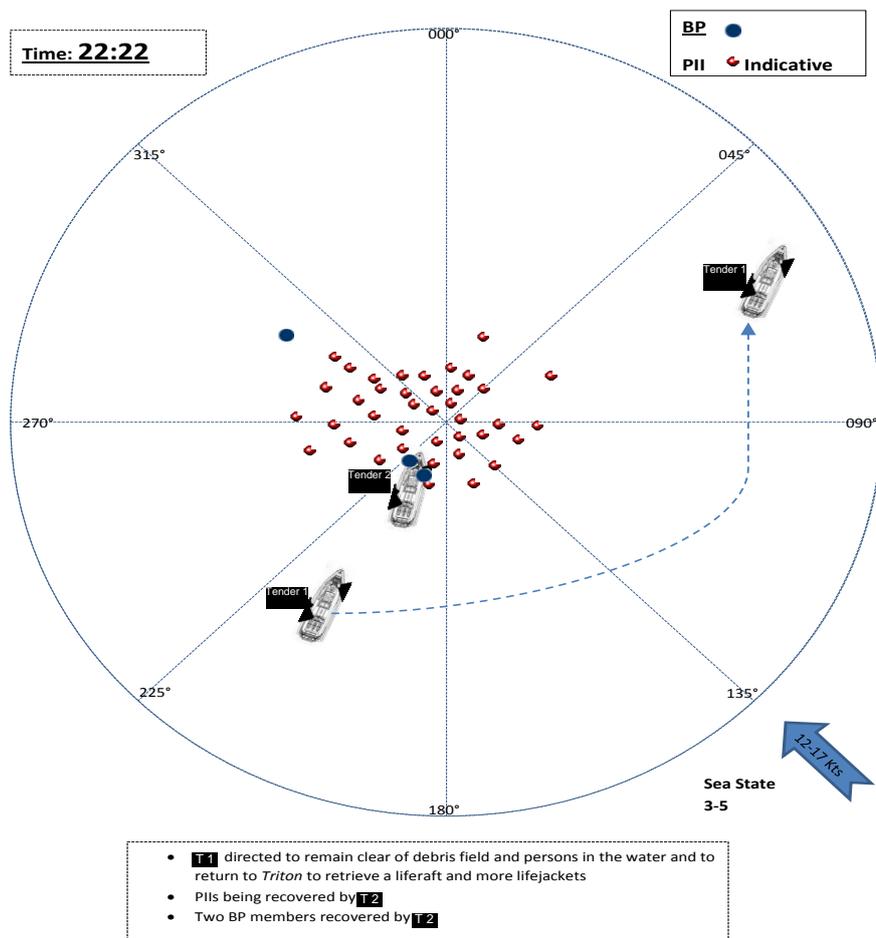
89. As Tender 2 moved further into the debris field and continued recovering people from the water, its starboard engine failed because of debris clogging the jet's intake. Shortly thereafter the port engine began to fail, also due to ingesting debris. Tender 2 situation was that her starboard engine was shut down, and the port engine was reduced to 40%, and she was quickly becoming overloaded with the large number of survivors being lifted onboard (Figure 6).

Figure 6: Tender 1 and Tender 2 movements at 22:22⁴

⁴ Diagrams 6, 7, 8 and 9 are intended to indicate the relative movement and positioning of Tender 1 and Tender 2 to the PIIs and BP members in the water. It is not a representation of the exact number of PIIs at any given point in the rescue effort nor of actual distances involved.

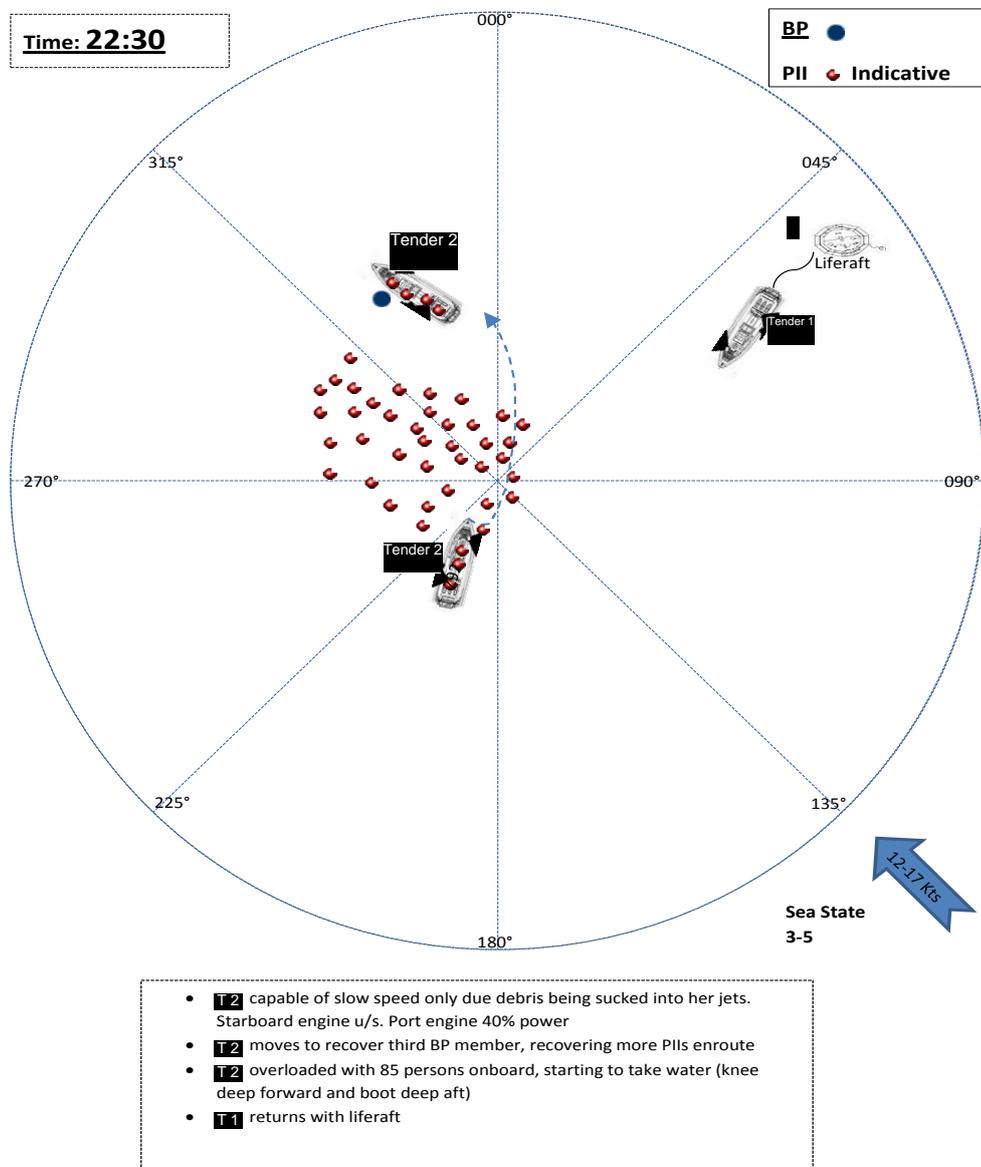
93. While Tender 1 was retrieving the liferaft, Tender 2 continued to recover PIIIs from the water. At 22:30 the third member of the BP (who had abandoned SIEV 784 from its starboard side) was sighted on the far side of the PIIIs and Tender 2 manoeuvred towards him very slowly using the damaged port engine only, moving through the remaining PIIIs and recovering them as she went ahead (Figure 7).

Figure 7: Tender 1 returns with liferaft. Tender 2 recovers 3rd BP (refer to footnote 4)

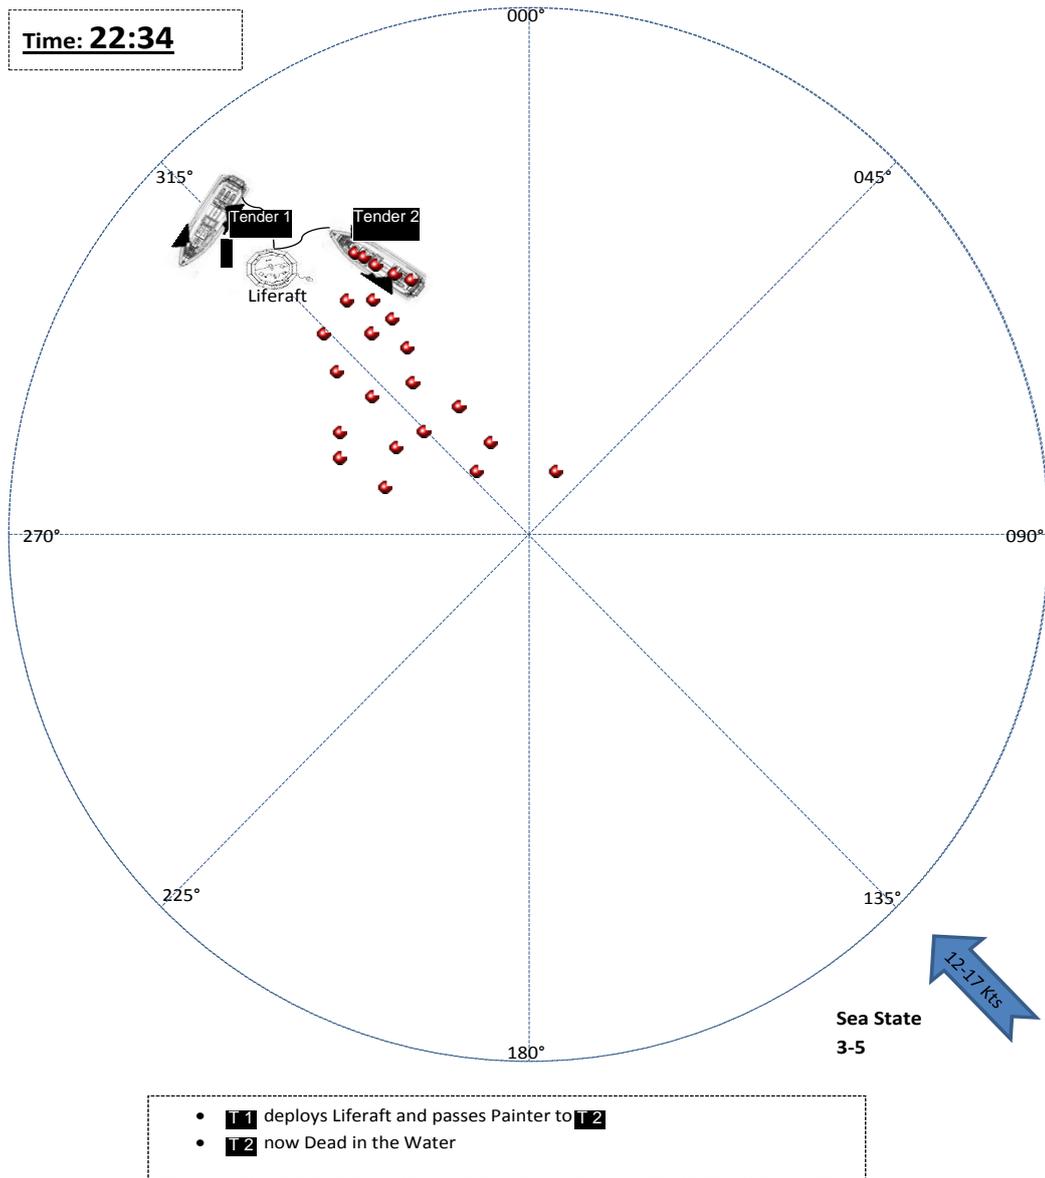
94. The BP member was recovered and shortly thereafter, at 22:34 **Tender 1** arrived back at the scene and deployed the liferaft (Figure 8). By this time, **Tender 2** had an estimated 85 PII's onboard and was grossly overloaded and had taken on an excessive amount of water. Deploying the liferaft helped to ease the overloading that **Tender 2** was experiencing by her being used as holding platform for the PII's.
95. The painter line of the liferaft was passed to **Tender 2** and the crew coordinated moving PII's into it so as to lessen the overloading on the tender. **Tender 2** crew struggled to keep the liferaft alongside and at one point it was blown astern before being hauled back alongside.

Figure 8: **Tender 1** deploys liferaft and passes it to **Tender 2** (refer to footnote 4)

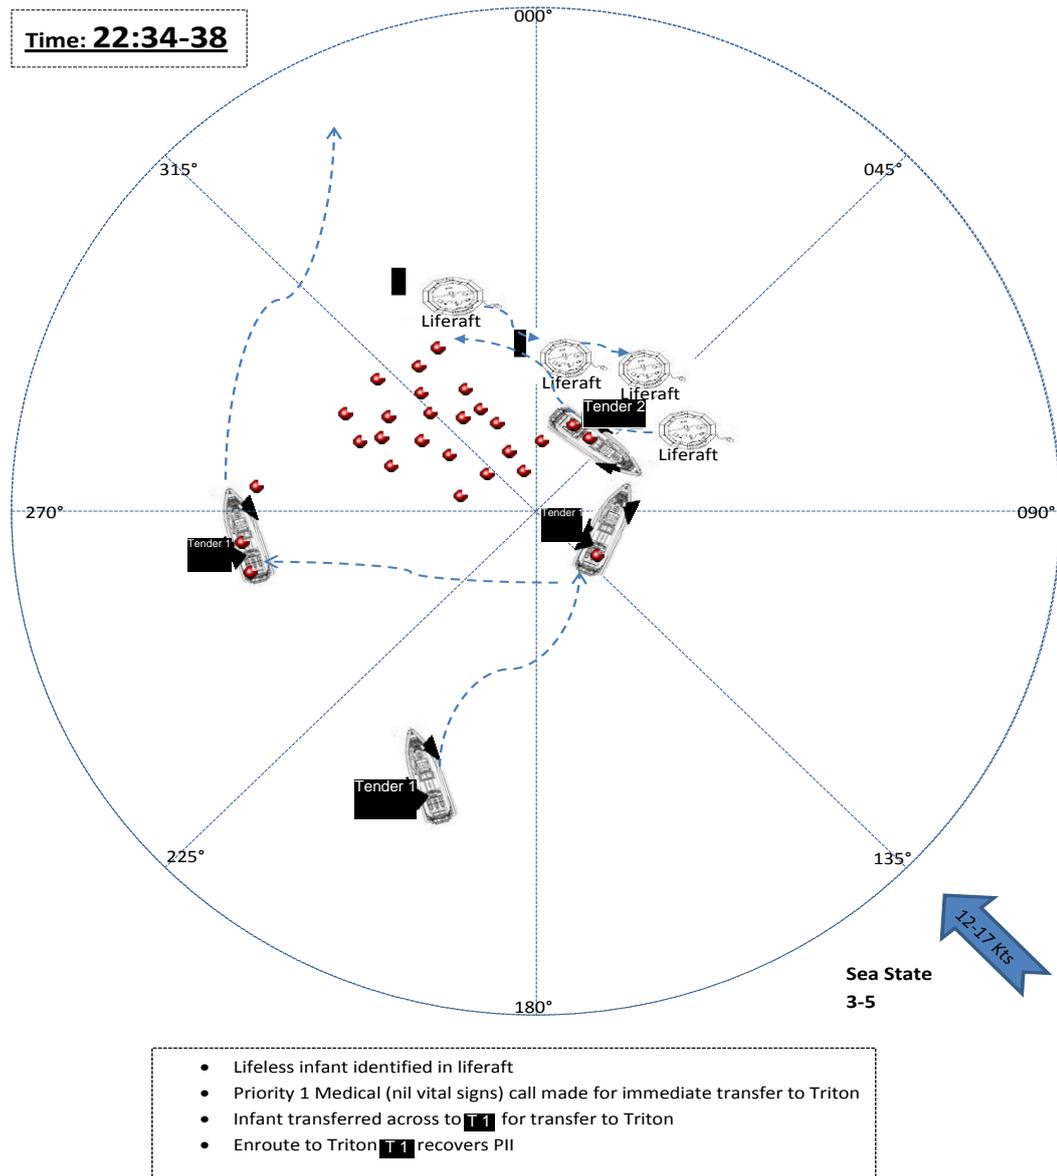
Figure 9: Liferaft secured alongside **Tender 2 Infant transferred to **Tender 1** and then *Triton* (refer to footnote 4)**

97. At 22:42 she was hoisted onboard and the infant was passed to the ship's medical staff. Despite their best efforts, the medical staff were not able to revive the infant and at 23:07 *Triton* called AMSOC to advise that the infant was deceased (Figure 9).

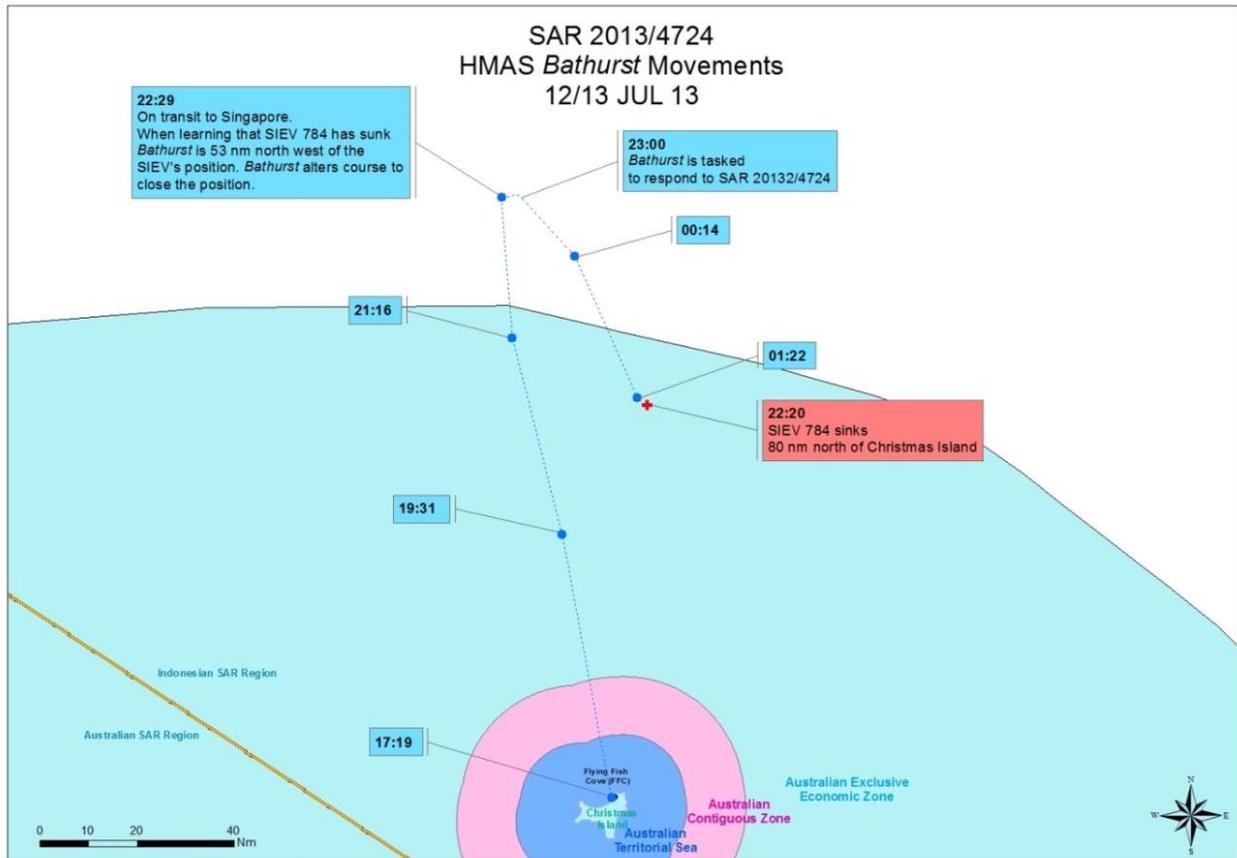
Figure 10: HMAS Bathurst Movements

115. After the departure of *Triton*, under *Bathurst's* direction, the remaining surface vessels continued a coordinated search of the area for any further survivors. While lifejackets and other debris were sighted, there were no further sightings of either survivors or bodies.

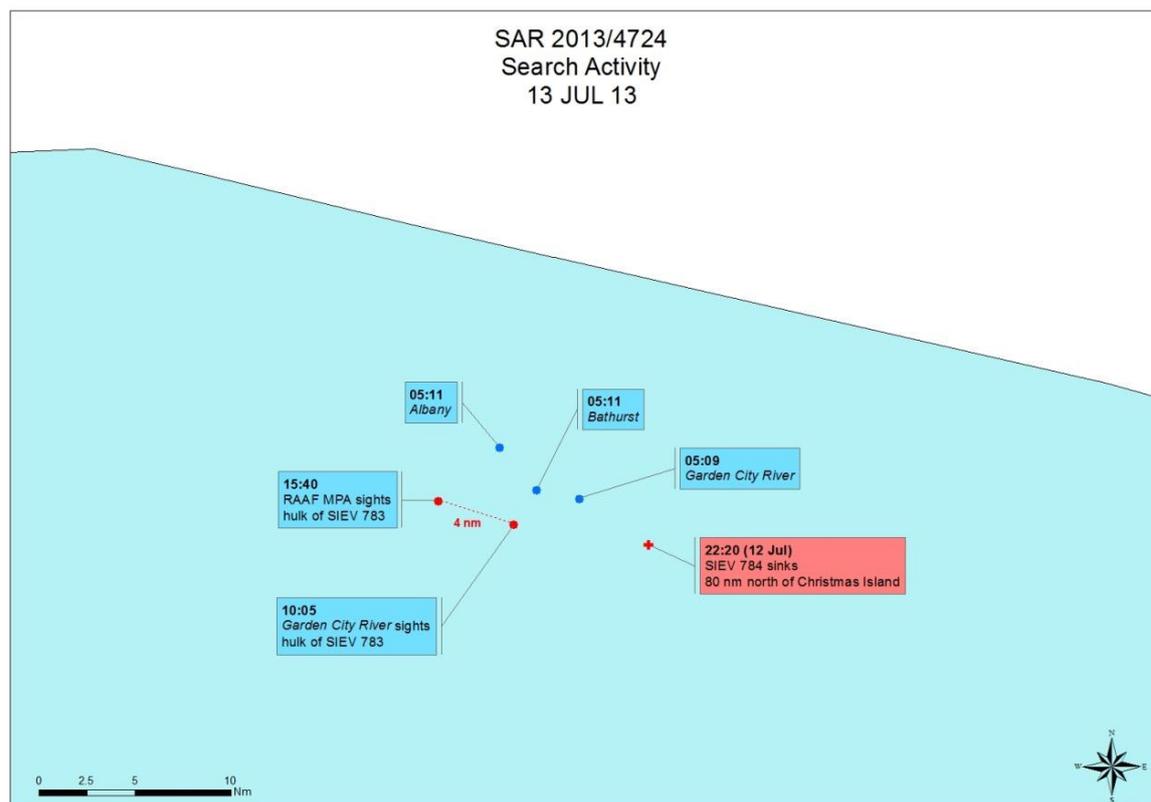
Figure 11: Search Activity

119. At 11:08 *Bathurst* provided RCC with their latest drift assessment and requested updated search areas. At 12:30 *Bathurst* received these and advised RCC of its intent to continue with the search while daylight remains.
120. At 13:00 the RAAF MPA arrived on station. It conducted the search plan previously developed by RCC and during its patrol it sights an upturned hull (the same one previously sighted by *Garden City River*), a cluster of life jackets and a submerged liferaft (from *Triton*). At 17:23 the aircraft is at its prudent limit of endurance and discontinues the search after having covered 50%⁸ of search area (Figure 11).

121. At 20:40 *Bathurst* advised RCC that 90% of search area has been completed and anticipated completing 100% by last light (in approximately 30 minutes).
122. At 21:50 BPC is advised by RCC that *Bathurst* and *Albany* are released from SAR 2013/4724 tasking as is *Garden City River*.
123. At 21:58 *Bathurst* was directed to detach and proceed to SAR 2013/4753. At 22:05 CJOPS issues the CEASO formally cancelling ADF support to the SAR.
124. At 00:03 14 July RCC advised BPC that due to the integrity of the search and that medical advice they had received was that survival was no longer possible, search activities for SAR 2013/4724 had been suspended. At 08:55 RCC emailed AMSOC cancelling their original Urgency signal.

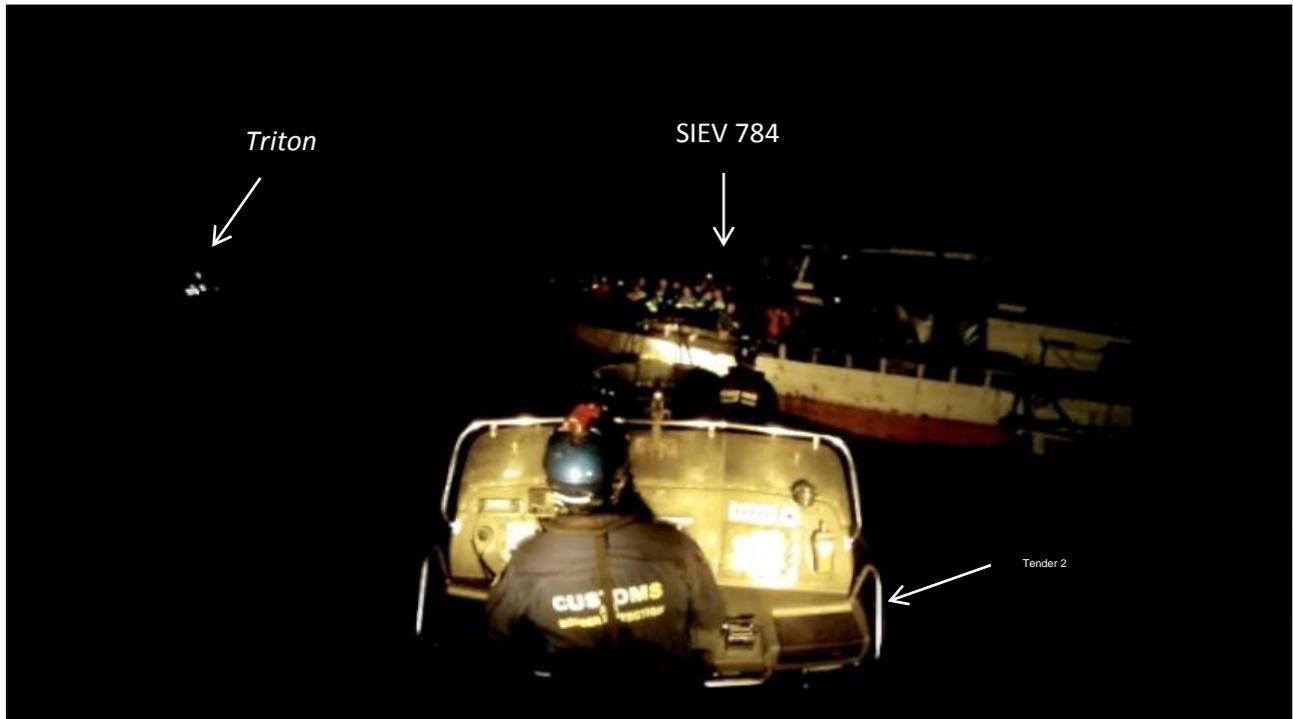
- The Review found that SIEV 784 sank as a result of being swamped by two large waves shortly after being boarded by *Triton's* BP. By not making way through the water, SIEV 784's beam/stern was presented to the sea which left her vulnerable to being swamped.

Figure 12: Tender approaching SIEV 784

144. Upon boarding the BP found that SIEV 784 had approximately 20 cm of water in its engine bay bilge and one of the PIIs was operating a manual bilge pump. The engine was stopped and in the short time remaining before she sank there was no opportunity to restart it.

145. It is not known whether SIEV 784's engine being stopped was the result of a deliberate act by the crew or the PIIs, water ingress or some other mechanical fault. In the SIEV 784 crew statements to the AFP two of the three crewmen claimed that the BP instructed them to turn the engine off and the third stated that the engine stopped because of water ingress. The available information from *Garden City River* as they closed SIEV 784's position was that the vessel was not making way. Additionally, the BC confirmed when he boarded SIEV 784 that vessel was not making way and her engine was stopped.

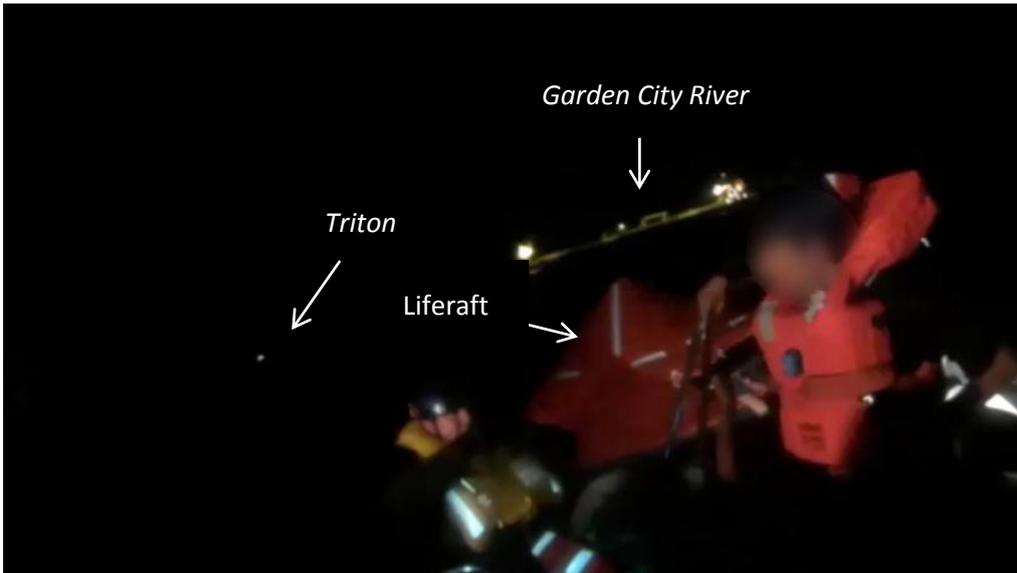
Figure 13: Z92 and the life raft holding rescued PII (Note: *Garden City River* and *Triton* in the background)

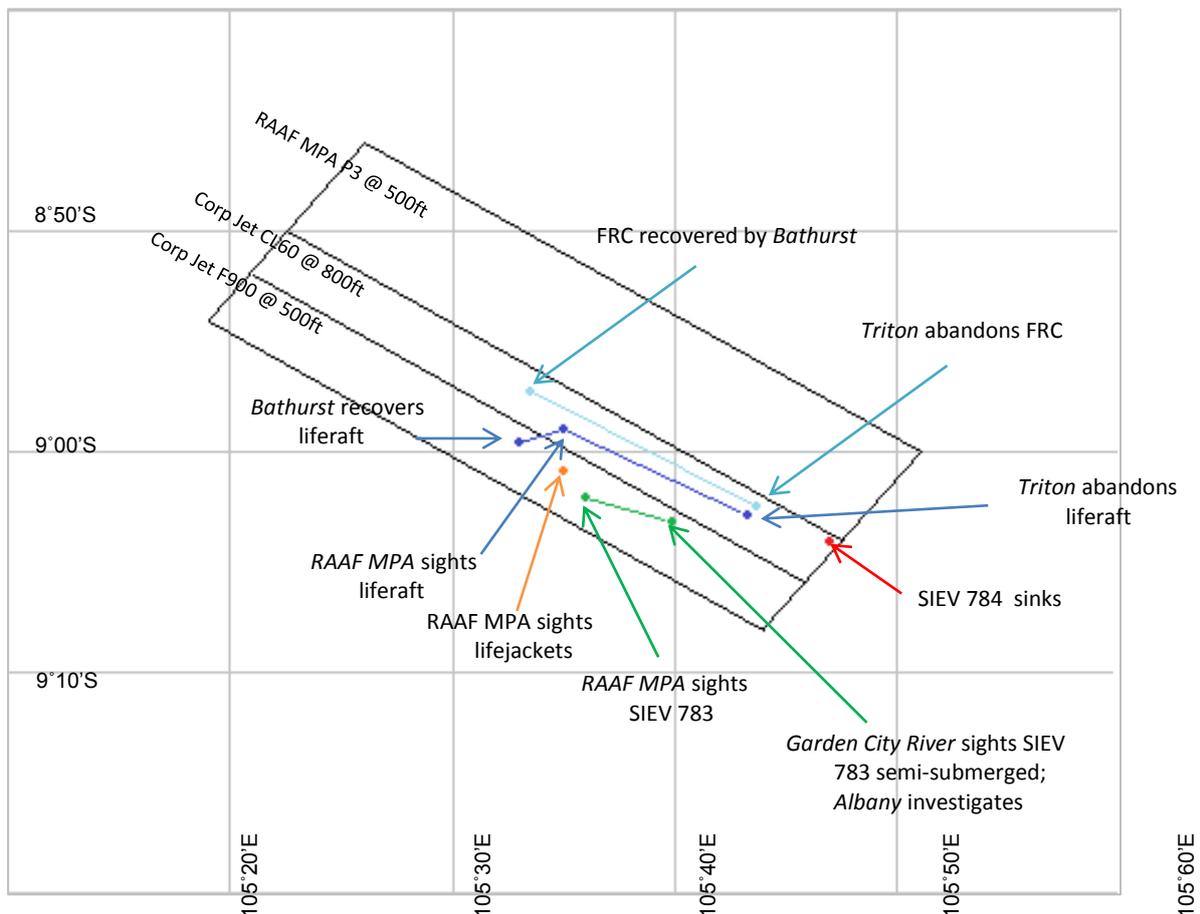
Figure 14: Sightings and Air Search¹²

During this 22 hour period, the surface search conducted by the vessels had covered over 100 sq nm with the air search covering over 445 sq nm. Search patterns were based on the direction of the wind and sea, giving the likely direction of drift at the time.

161. Figure 14 provides an indicative overview of the RCC search plan for the RAAF MPA and the initial two corporate jets assigned.

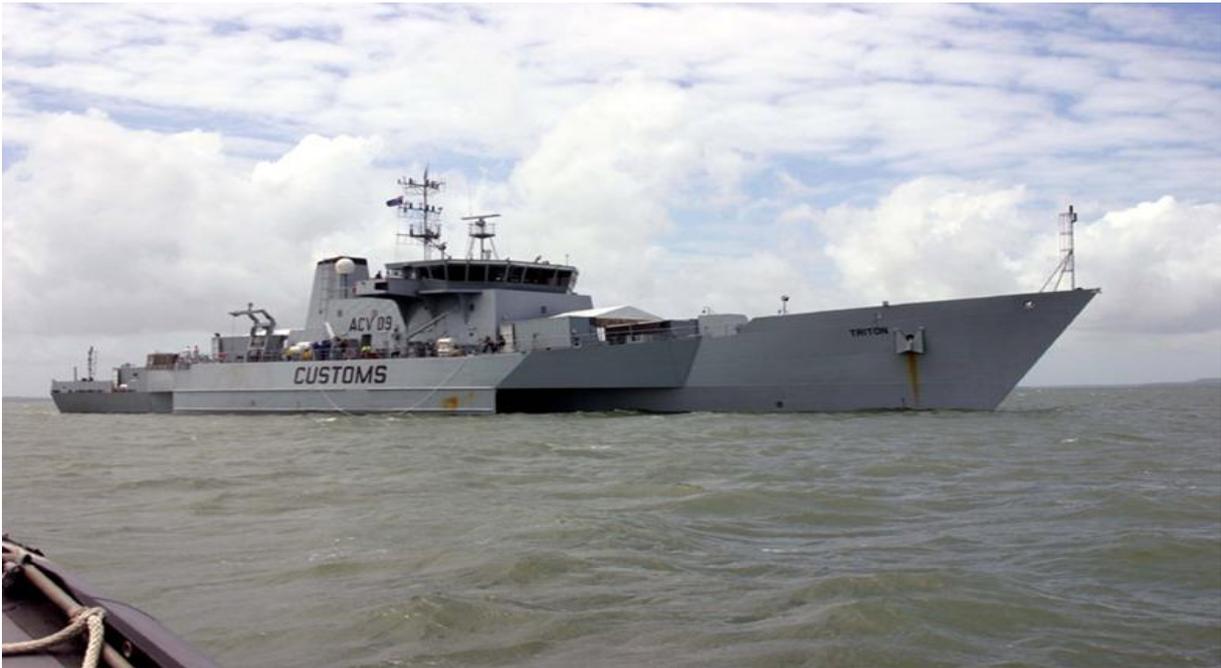
ACV Triton	
Vessel involved	ACV Triton
Role in SAR 2013/4724	First vessel to respond to SAR 2013/4724. Rescued PIs and was initial OSC
Flag	Australia
Type	Patrol Boat
Launched	1998 (leased to Customs and Border Protection December 2006)
Length	98 metres
Beam	22.5 metres
Speed	20 knots
Maximum Range	12,600 nautical miles
Displacement	2,236 tonnes
Crew	A civilian maritime crew of 14, and can carry up to 28 armed Customs Boarding Party officers.
Surveillance Sensors	Search and Navigations radar

Capabilities attached to the parent system ACV Triton: two x Norsafe Magnum 850 tenders	
Length	8.87 metres
Beam	3.27 metres
Speed	35 knots with three crew
Maximum Range	60 nautical miles
Engine type:	Inboard Diesel
Standard engine size:	2 x 250Hp
Weight boat with equipment:	4.300 kgs
Propulsion:	2 X Waterjet
Deployment and Recovery	<ul style="list-style-type: none"> - The tenders are designed to launch and recover up to 12 persons and boarding equipment to and from the Norsafe davits; - The tender maximum boat load with 12 persons (100kg each and 200g Extra Load) is 6150kgs; - The tenders are restricted to ship speed up to 6 knots at launch and recovery;

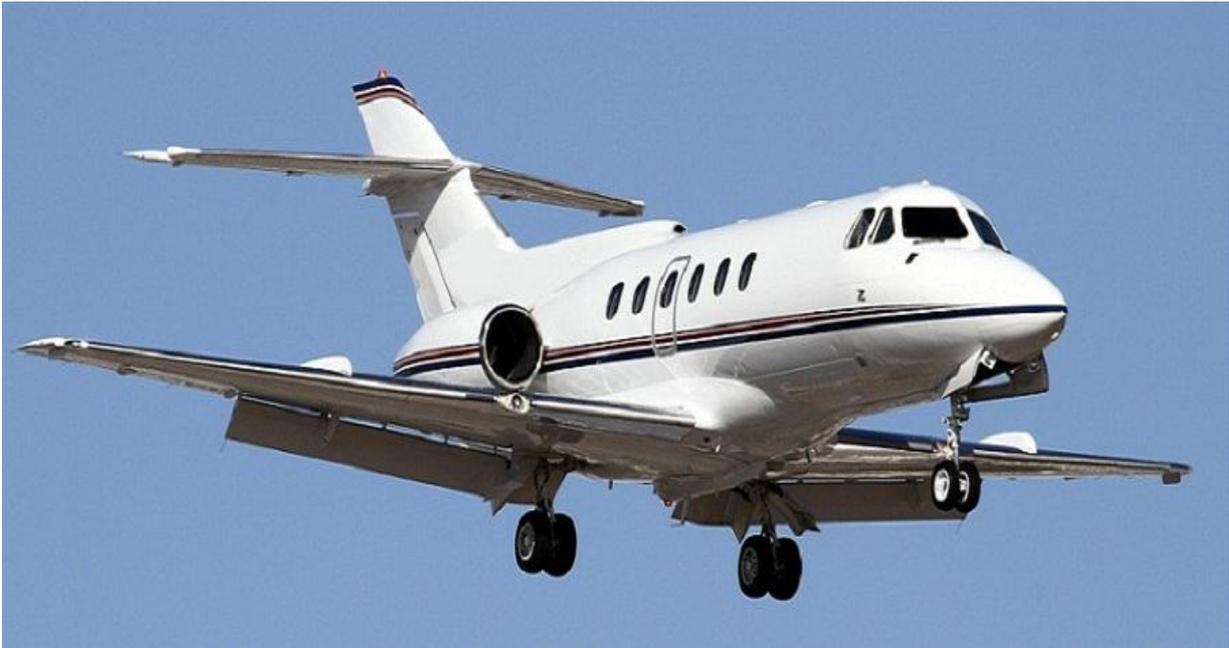
Corporate Jet 3- G150	
Role in SAR 2013/4724	Aerial search for survivors on 13 July
Speed	430 – 460 knots
Range	3,000 nautical miles
Ceiling	45,000 ft.
