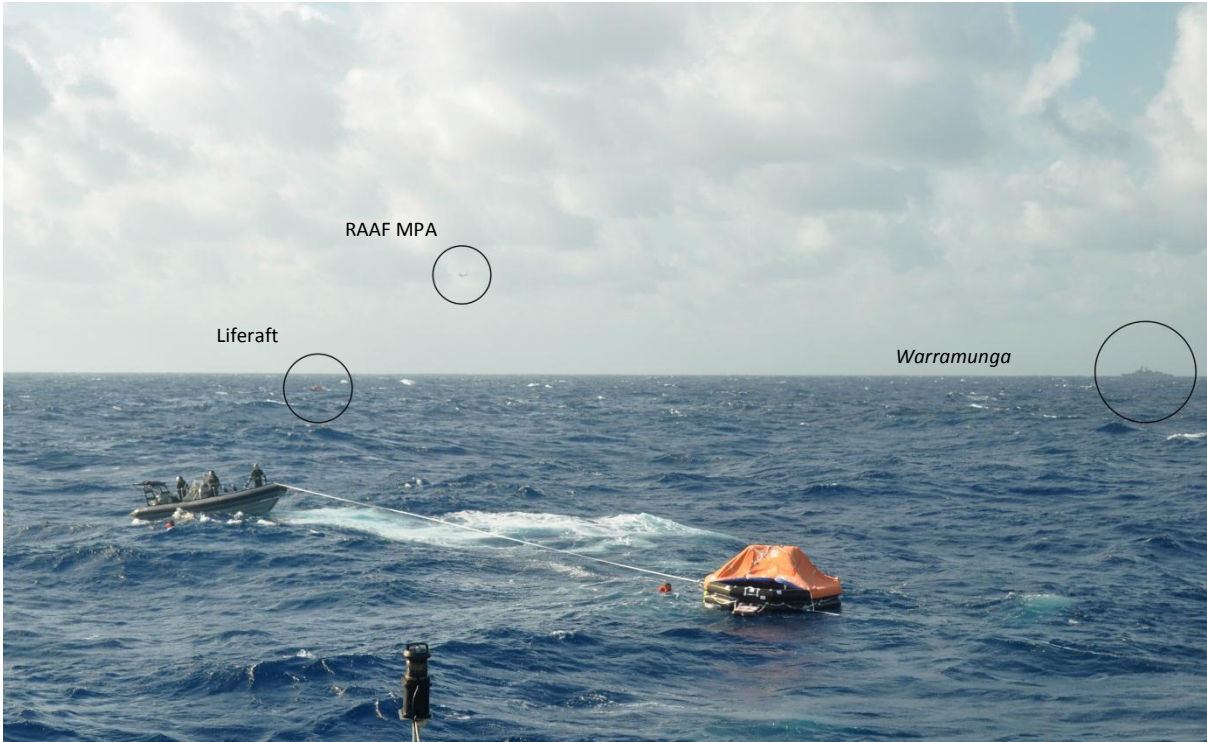
Figure 9. Assets involved in SAR 2013/4816

158. Figure 9 presents a pictorial representation of the assets involved in SAR 2013/4816. Taken from *Albany*, the RAAF MPA is pictured in the distant skyline, and *Warramunga* is positioned approximately 1.5 nm to the north. A RHIB is connected to a liferaft via its painter line, with a second liferaft in the distance, highlighting the span of the recovery efforts.
