SIEV 221

Internal review

Internal review relating to Customs and Border Protection
(including Border Protection Command) actions relating to SIEV 221

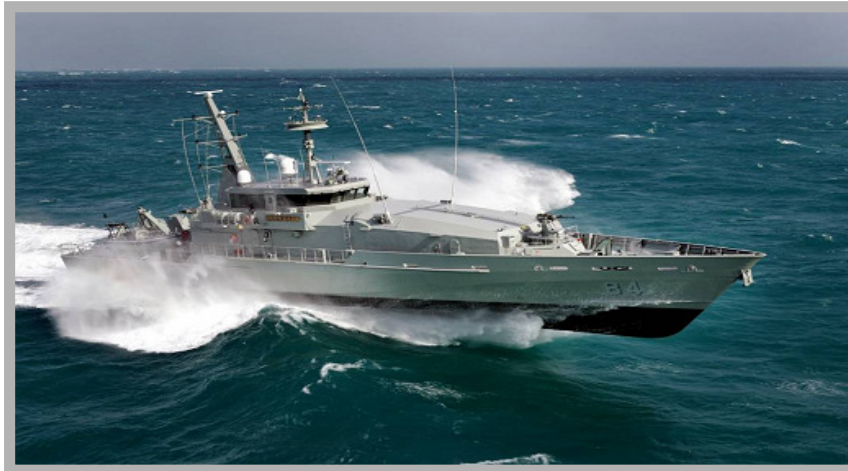
HMAS PIRIE CAPABILITY AND LIMITATIONS

- Length: 56.8m
- Beam: 9.5m
- Displacement: 305 tonnes
- Maximum Speed:
 - 2 Engines: 25 knots
 - 1 Engine: 15 knots
- Economical Speed: 12-16 knots
- PII capacity: 35 (normal operating conditions)
- Crew Size: 21
- Max Operational Sea State: Sea State 4
- Surveillance Sensors:
 - Radar: Bridgemaster X-Band Surface Search & Navigation Radar
 - Toplite Electro Optical Surveillance System
 - Prism III Radar Warning System
 - Warrlock Direction Finding Electronic Support System

- No of RHIBs 2 x Zodiac 733 Hurricane
- Size of RHIB: 7.2m
- Propulsion: Diesel - Jet propelled
- Maximum capacity:
 - Normal conditions: 16
 - Rough weather: 10
 - Emergency: 25
- Maximum Speed: 25 knots fully loaded in Sea state 4
- Maximum Speed for launch: 10 knots
- Maximum Sea State for launch:
 - Normal Operations: Sea State 4
 - Critical Operations: Sea State 6
- Maximum Sea State for operations:
 - Normal Operations: Sea State 4
 - Critical Operations: Sea State 6

198. HMAS *Pirie*'s procedures for operating the RHIBs in adverse conditions for the conduct of rescue operations are well documented and understood. The Navy requires that they are practiced regularly for the purposes of Man Overboard procedures and operational boardings. HMAS *Pirie*'s RHIBs are limited to Sea State 4 for normal operations but may be operated up to Sea State 6 in order to perform 'Critical Operations'.

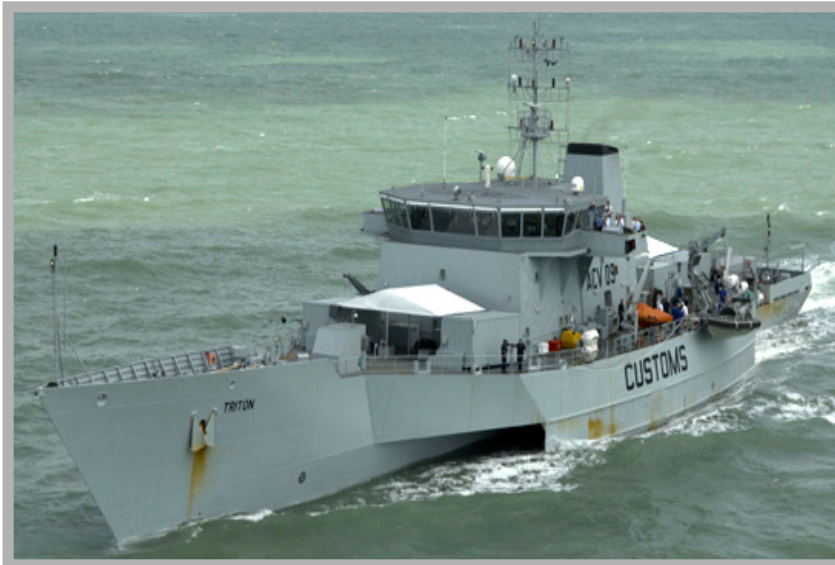
ACV TRITON CAPABILITY AND LIMITATIONS

- Length: 98m
- Beam: 22.5m
- Displacement: 2236 tonnes
- Maximum Speed:
 - 2 Engines: 20 knots
 - 1 Engine: 12 knots
- Economical Speed: 10-14.5 knots
- PII capacity: 68 (normal operating conditions)
- Crew Size:
 - 14 Gardline Crew for ship operation
 - 20 Marine Enforcement Officers for Law enforcement
- Max Operational Sea State: Sea State 4 (Survivable to Sea State 8)
- Surveillance Sensor:
 - Radar: Bridgemaster X-Band Surface Search & Navigation Radar

- No of RHIBs: 2 x Norsafe 850
- Size of RHIB: 8.5m
- Propulsion: Twin 233hp diesel - Jet propelled
- Maximum capacity:
 - Normal conditions: 12 (Coxswain, Bowman + 10 BP)
- Maximum Speed: 38 knots 3 personnel embarked
- Maximum Speed for launch: 6 knots
- Maximum Sea State for launch: Sea State 4
- Maximum Sea State for operations: Sea State 4

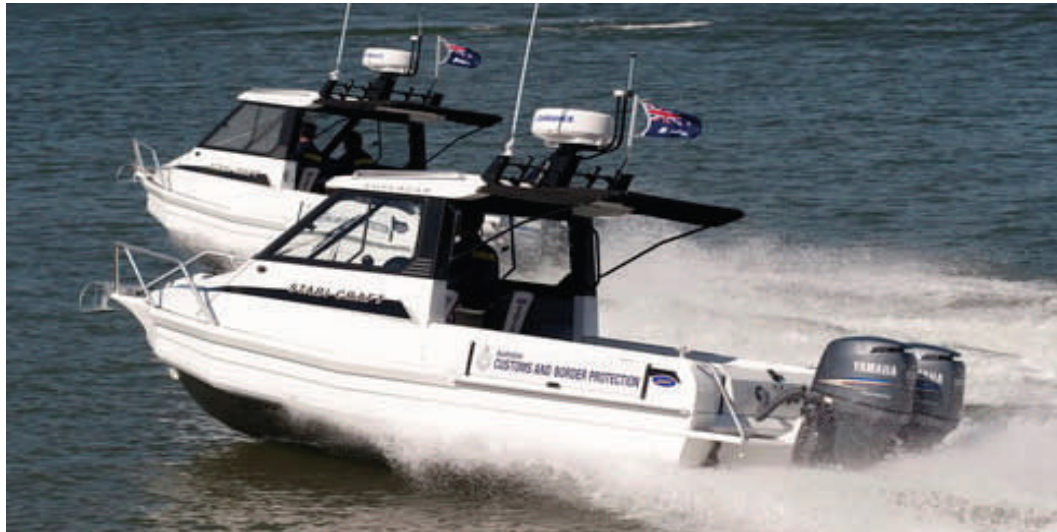
Port Class TV13 CAPABILITY AND LIMITATIONS

- Length: 6.59m
- Beam: 2.50m
- Displacement: 1,630kg
- Maximum Speed:
 - 2 Engines: 200hp
- Economical Speed: 37.3 knots
- PII capacity: 4 (normal operating conditions)
- Crew Size: 6 (including a minimum of 2 crew)
- Max Operational Sea State: Smooth and partially smooth waters operations as defined in Part B of the NSCV, with no more than 6 people on board, whilst operated by a Commonwealth Authority.
- Definitions
 - **smooth waters**— waters where the significant wave height does not exceed 0.5 m from trough to crest for at least 90 per cent of the time.
 - **partially smooth waters**— waters where the significant wave height does not exceed 1.5 m from trough to crest for at least 90 per cent of the time.

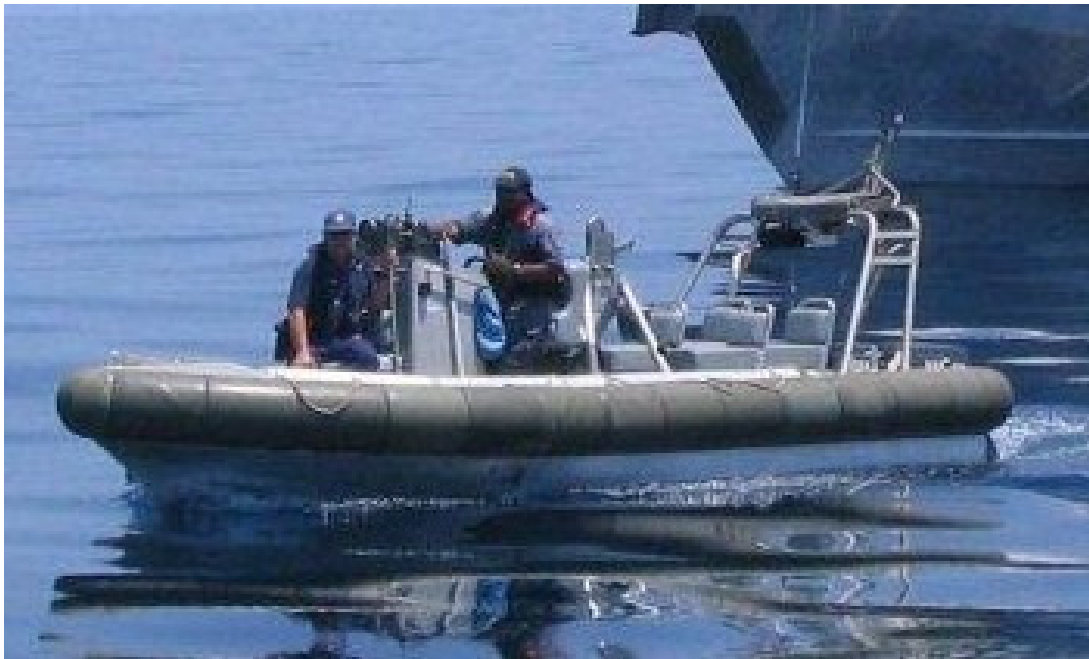
Wiltrading 640 (Hull ID 68) CAPABILITY AND LIMITATIONS

SHIP – Customs Response Tender (CRT)

- Length: 6.4m
- Beam: 2.2m
- Displacement: 1450kg
- Maximum Speed:
 - 2 Engines: 35 knots
- Crew Size: 8 (including a minimum of 2 crew)
- Max Operational Sea State: Sea State 3
